Impacts of Sediment Loading and Siltation in the GBE

Fred Short, JEL, UNH

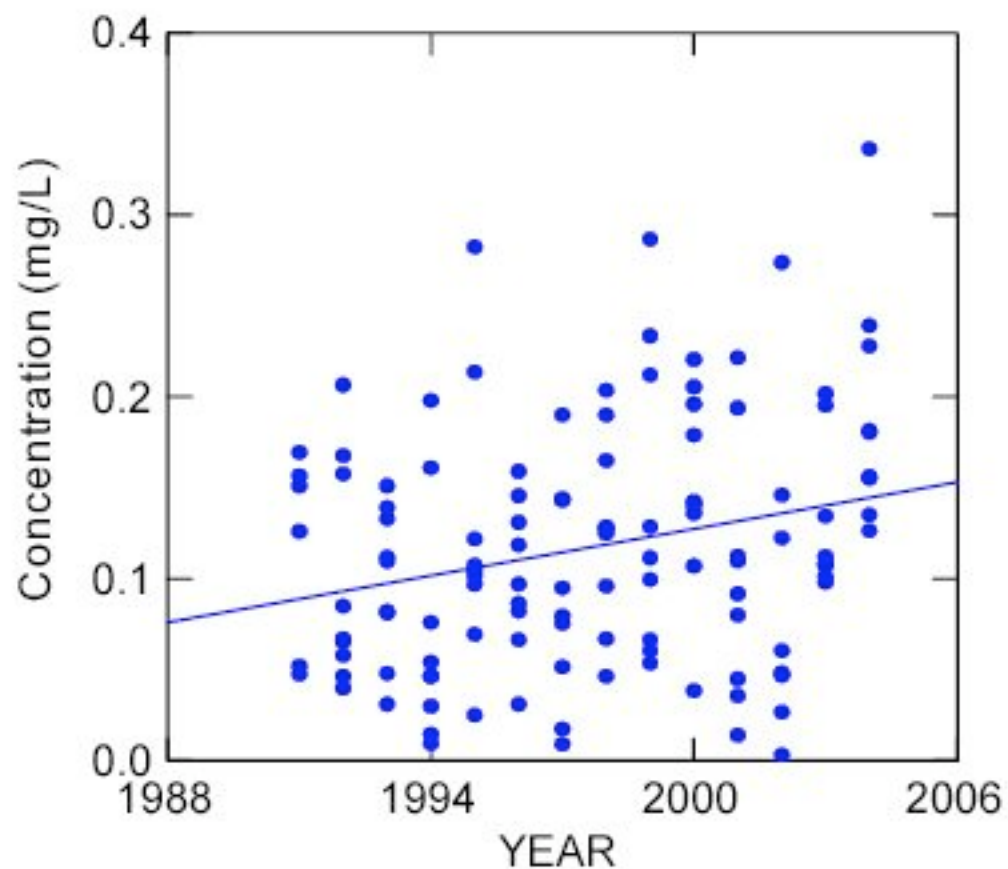
Chapmans Landing in the Squamscott River

Nitrogen, Nitrate + Nitrite as N

Statistically Significant Trends

Nitrogen, Nitrate+Nitrite as N = $0.00428 * \text{YEAR} - 8.440$ ($P=0.005$)

Percent Change 1991-2004 = 63%

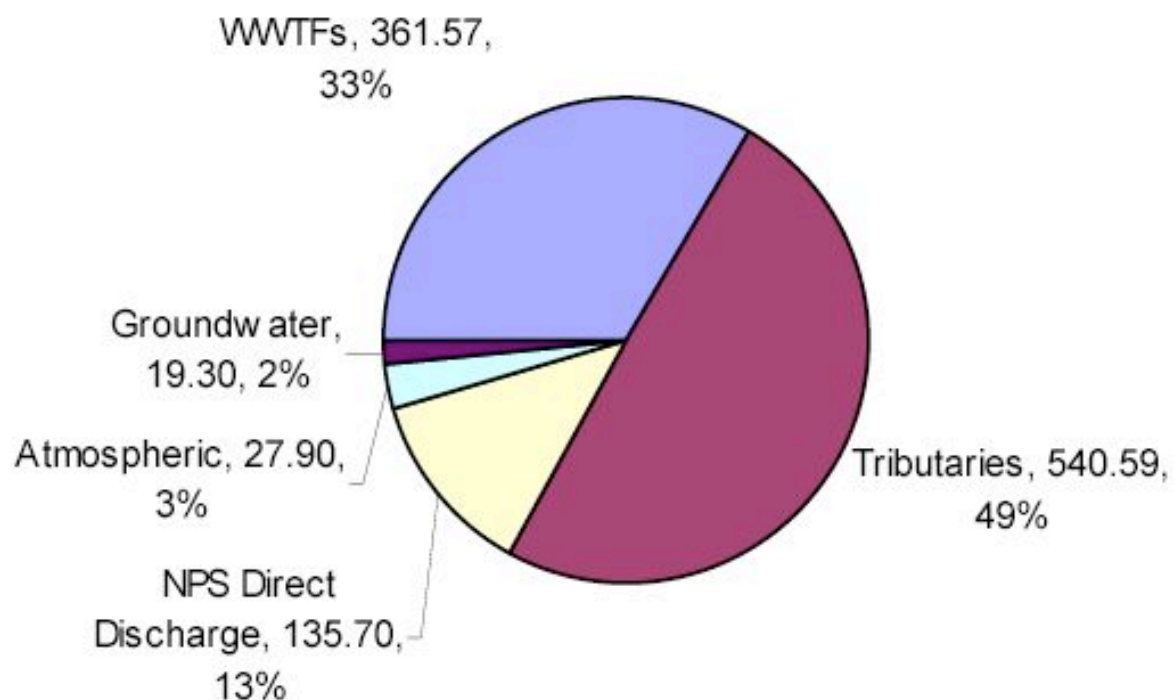
Figure 30: Total nitrogen loads to the Great Bay and Upper Piscataqua River estuaries by source category assuming 50% of WWTF loads in the lower Piscataqua River enter the system

**Great Bay and Upper Piscataqua River Estuary
Total Nitrogen Loads in tons N per year**

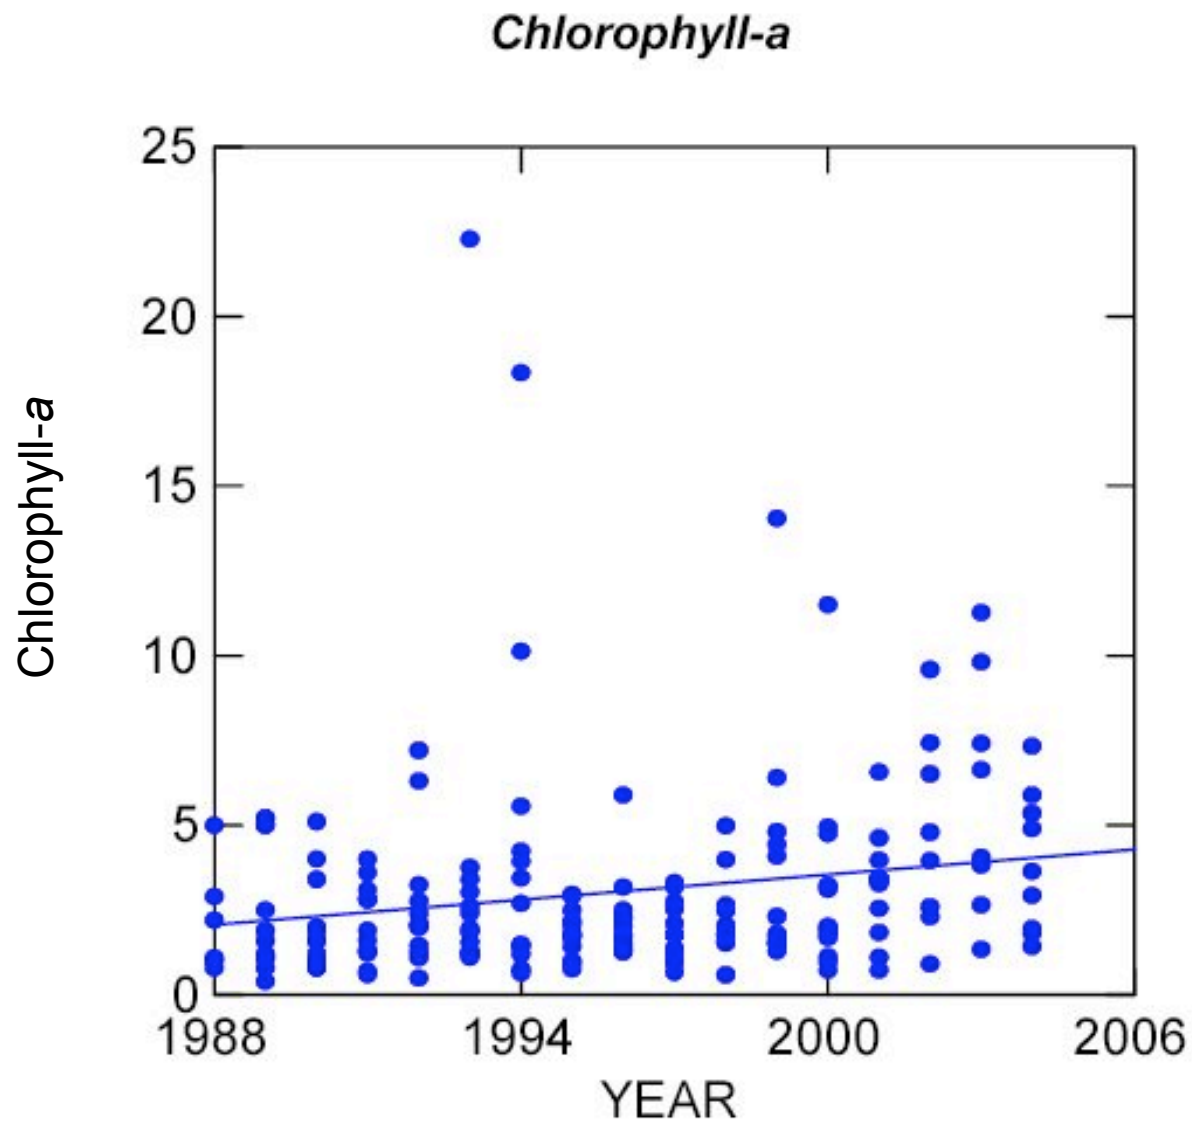
Statistically Significant Trends

Chlorophyll-a = $0.124 * \text{YEAR} - 243.9$ Percent Change 1988-2004 = 76%
